Advanced Epoxy Timber Pile Repair – Stage 1 and Stage 2

Peter Dwyer, Eunice Chaw, Atteeq Ur-Rehman January 2024 Final Report

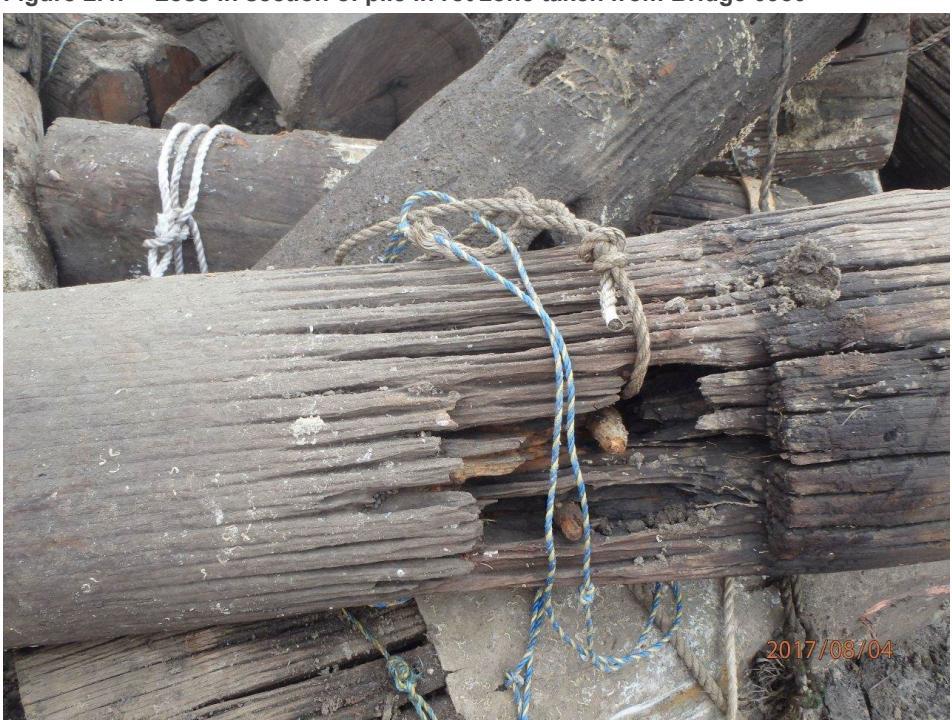
Figure 2.4: Loss in section of pile in rot zone taken from Bridge 0950

The first recorded use of epoxy resin as a design solution was on Main Roads Bridge 0950, Garratt Road, in the 1990s. Main Roads observed significant section loss in the pile at the rot zone, similar in nature to Figure 2.4. As the pile's loss of section was not yet severe enough to warrant structural replacement, Main Roads made the decision to attempt a less intrusive preservation solution, wrapping the pile in acrylic sheet and coating it in epoxy resin. The epoxy resin utilised is unknown.

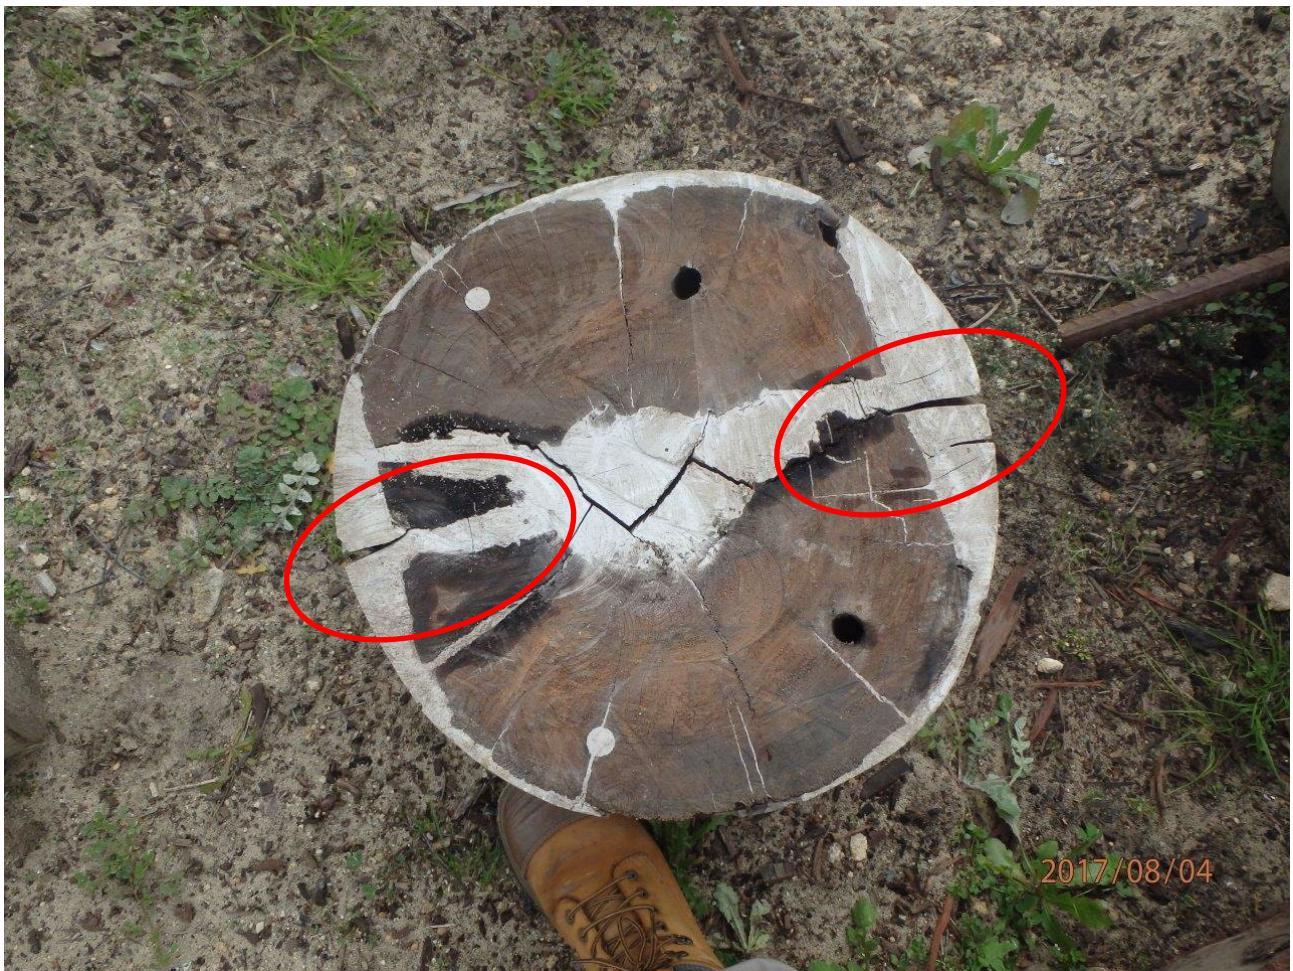
Figure 2.5: Section of repaired pile taken from Bridge 0950

Bridge 0950 recently underwent further asset management works, at which point Main Roads had the opportunity to remove a resin cast section of pile, shown in Figure 2.5. The timber pile shows lack of decay, with epoxy penetration into both large and minor cross-sectional cracks. Cracks formed in the outer annulus of the epoxy resin have not extended throughout the cross-section as indicated in red in Figure 2.5

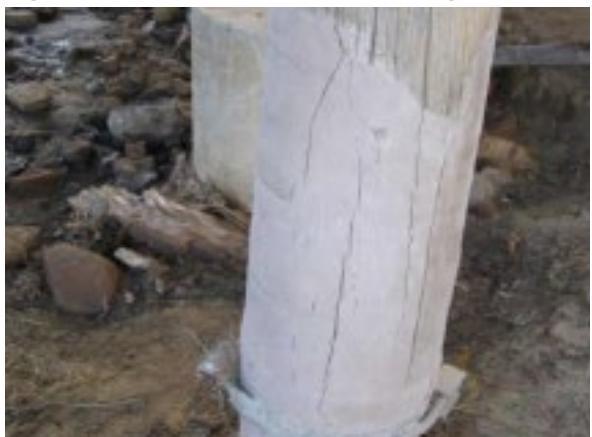
Figure 2.6: Resin coated pile on Bridge 752

Main Roads observed that the external resin annulus appeared to crack along pre-existing splits shortly after the repairs had been undertaken. As the cracks terminated close to the surface of the annulus and did not propagate throughout the pile, The cracks were deemed to have no effect on performance; however, it does appear aesthetically unpleasant as shown in Figure 2.5 and Figure 2.6

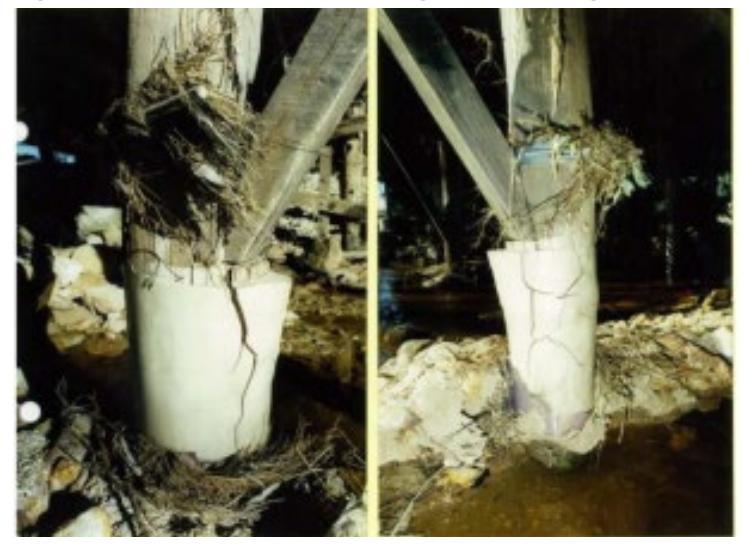
Figure 2.7: Thick annulus cracking apart on Bridge 0782.

Main Roads utilised the developed practice note as referred to in Section 2.3.2 to repair the piles on Bridge 0782. One pile featured a diagonal strut resulting in an excessively thick annulus that presented severe cracking shortly after the repairs. (Figure 2.7)

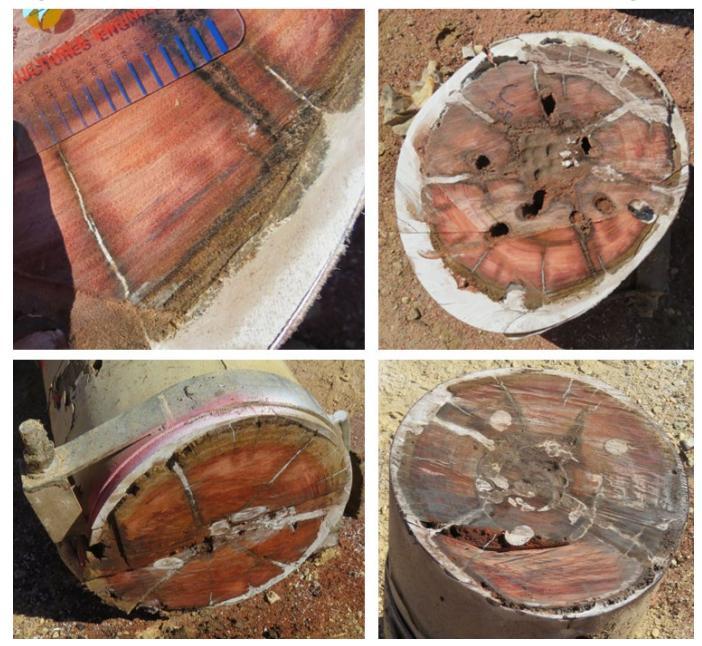
Figure 2.8: Removed piles with cut sections on Bridge 0782

Main Roads recently removed the treated piles on Bridge 0782 and cut slices in the timber to inspect the internal condition (Figure 2.8). The timber inside was preserved in excellent condition, with epoxy penetration to cracks as thin as 0.2 mm.

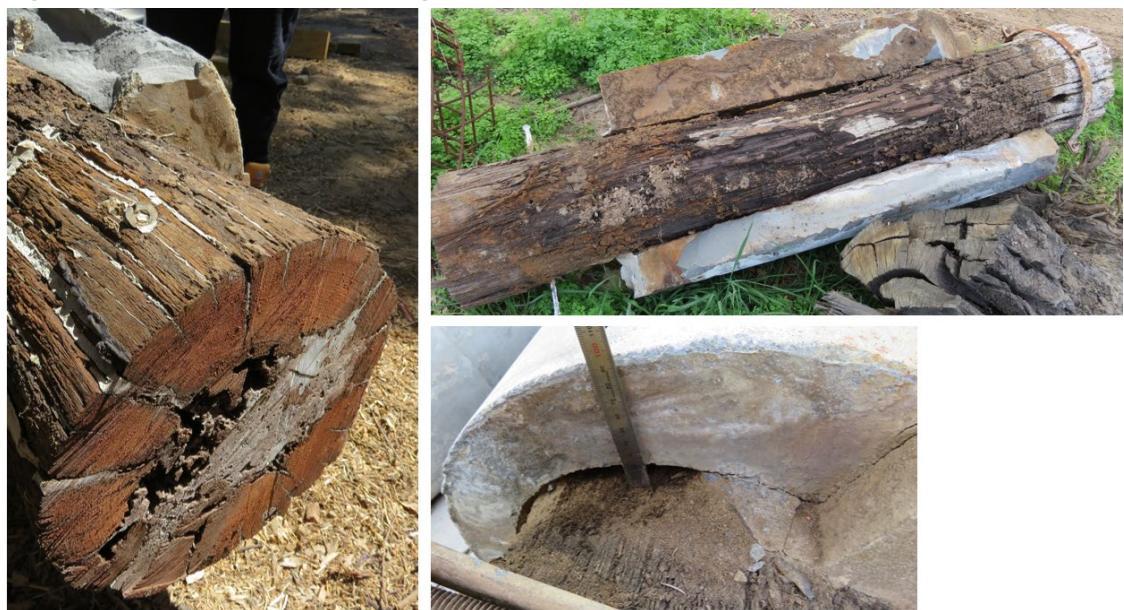
Figure 2.9: Removed piles on Bridge 0672

These concerns were confirmed on Bridge 0672, where Main Roads observed that if there was significant internal pipe that the grout had failed to penetrate and the pipe continued above the top of the rot, moisture and oxygen levels within the pipe remained sufficient for rotting to continue within the repaired zone (Figure 2.9). Notably, if the timber pile was solid at the top of the encasement, insufficient oxygen was present for the piles to rot.

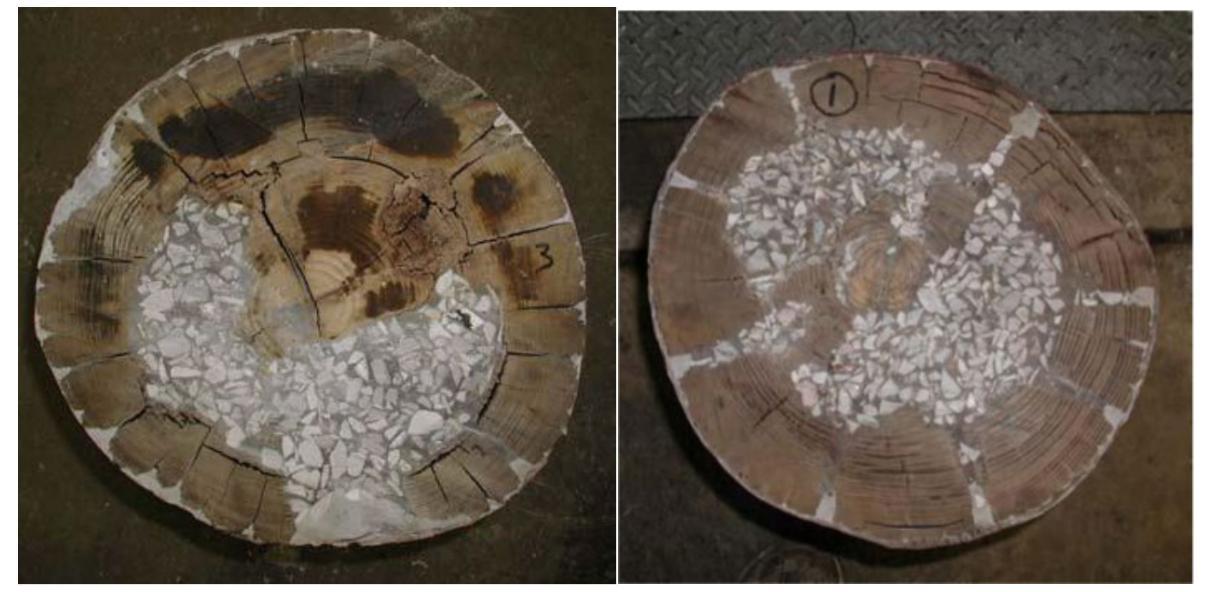
Figure 3.1: Cross-sections of repaired piles utilising the Oklahoma DoT method

A cross-section of a pile that was treated through the Oklahoma DoT method is shown in Figure 3.1 (Emerson 2004). Oklahoma DoT proceeded to test the piles repaired with this method under axial compression. The piles failed with timber splitting from the central core and collapsing in compression. Added strength could not be quantified, and it was noted that the piles failed below design axial strength.

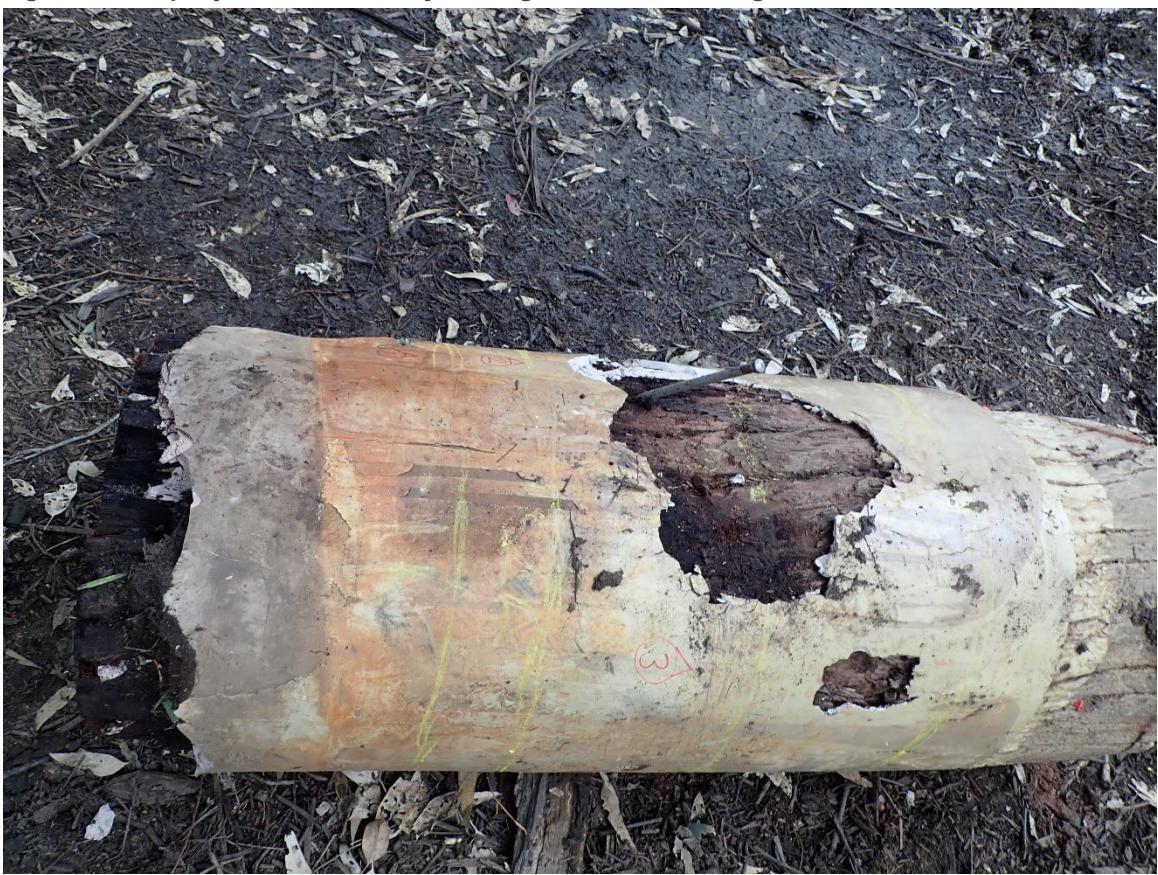
The technical staff at Peerless Industrial Systems commented that the primary problem faced in the field when using Epigen 0301MRD was avoiding uncontrolled exotherm, an event in which the chemical reaction of the epoxy resin setting creates excess heat which compromises the quality of the casting. Uncontrolled exotherm in epoxies is characterised by a surface yellowing and crazing. Main Roads noted this phenomenon was observed in piles extracted from a structure treated with Epigen 0301MRD approximately 20 years ago, as shown in Figure 3.2.

Figure 3.2: Epoxy resin with noted yellowing and surface crazing

Although excessive internal cracking was not observed throughout these samples, Peerless Industrial Systems warned that this cracking can often be representative throughout an entire sectional area, leading to a reduced life of the repair.

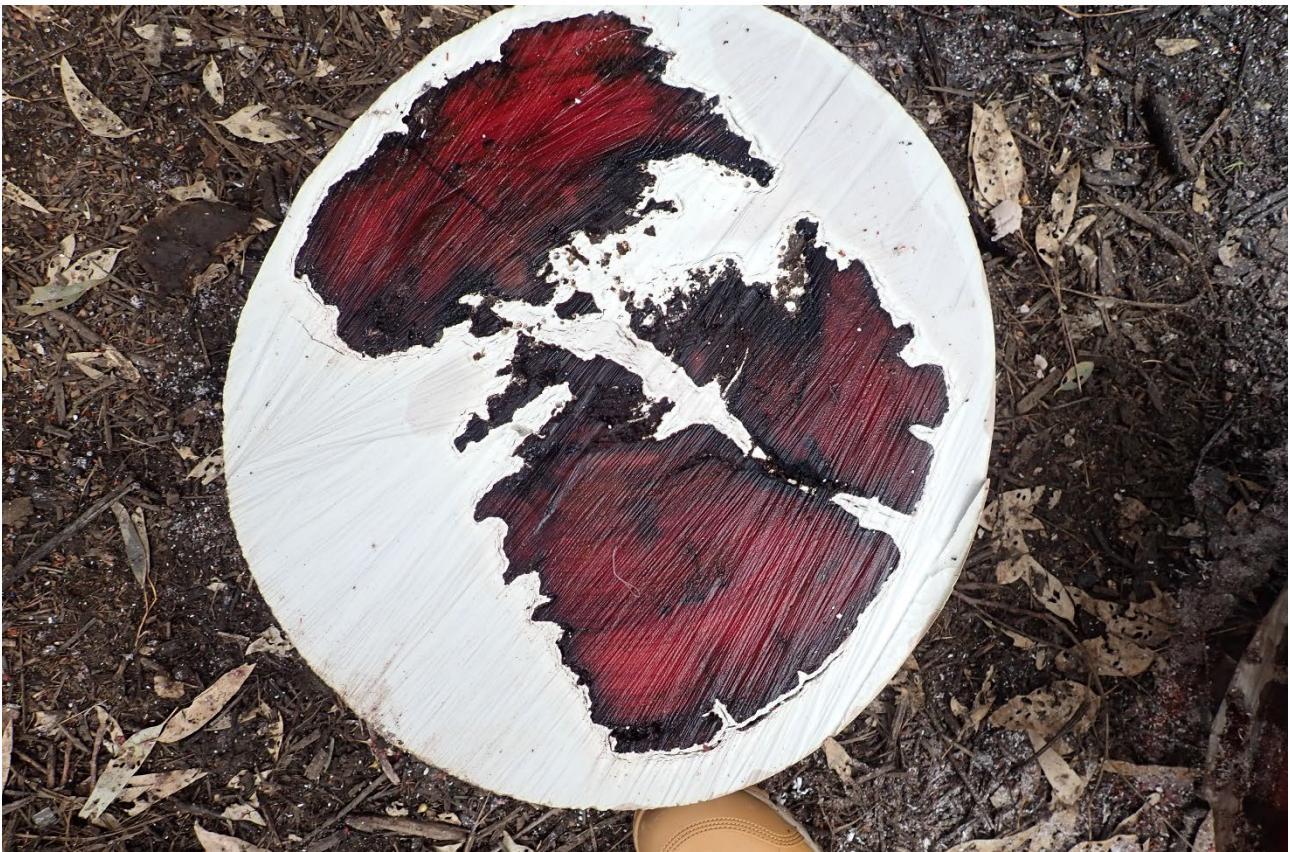
Figure 3.3: Cross section of Epigen 0301MRD repaired pile

Further cross-sections taken from these piles, treated 20-years ago, show good overall penetration (Figure 3.3) of the epoxy into the hollow pipe region, although not without areas of voids where the epoxy did not flow due to debris or decayed matter that was not removed in the preparation process (Figure 3.4).

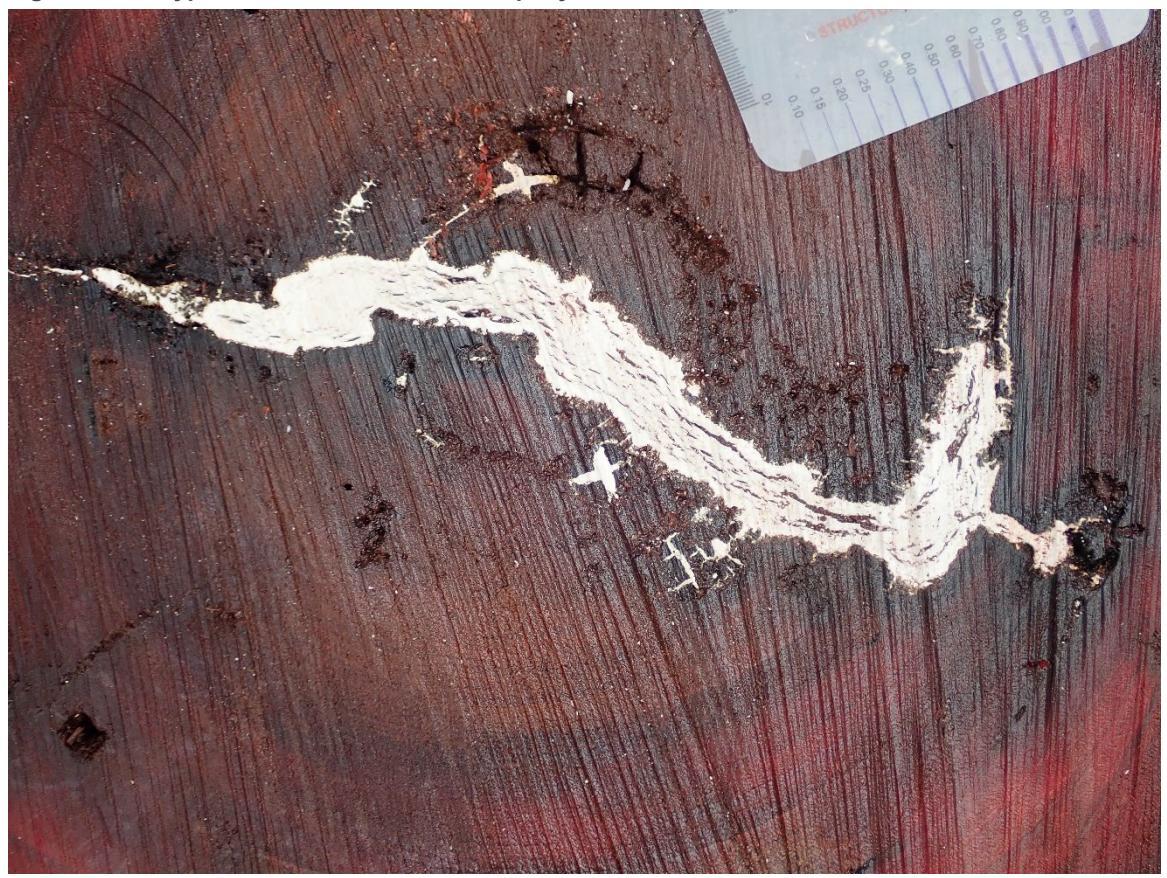
Figure 3.4: Typical minor sections where epoxy has not flowed

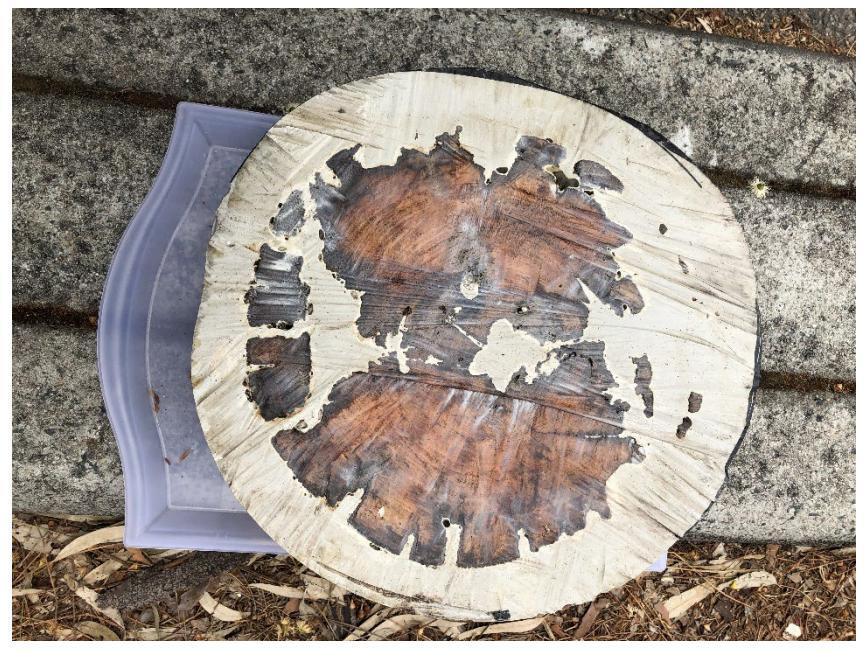
Figure 4.4: Section of pile treated with Epigen 0301MRD

Overall, the Epigen appeared to have flowed well, penetrating all notable cracks in the section (Figure 4.4). Minor voids remained in the section where the formwork had not been fully sealed, or where debris had not beenadequately consumed.

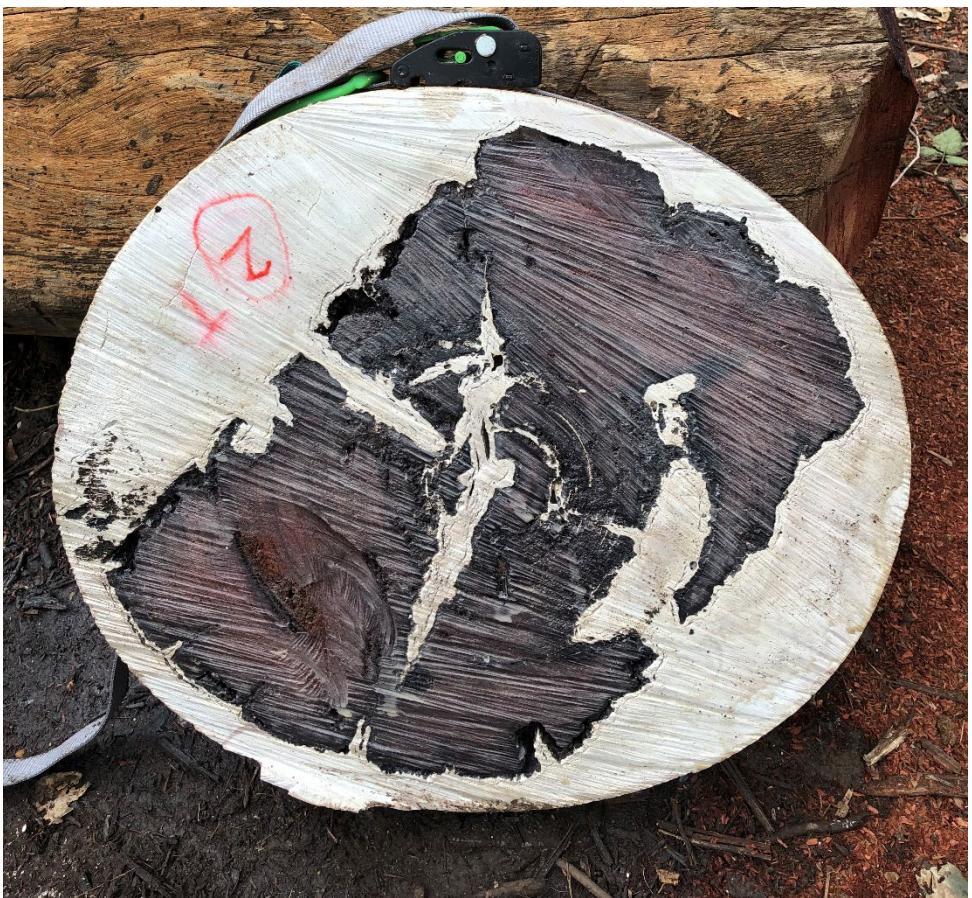
Figure 4.5: Section of 20-year-old pile treated with Epigen 0301MRD

While these new trials were being undertaken, Main Roads took the opportunity to remove a pile that had previously been treated with Epigen 0301MRD on the same bridge 20 years prior. This would allow a direct comparison between old and new works and show the longevity of existing works on piles exposed to equivalent conditions. Figure 4.5 shows the 20-year-old slice and reaffirms previous findings that if good penetration of epoxy has been achieved, further decay of the pile will effectively halt. Therefore, it is expected that had the current treated pile been left in situ, it would have achieved similar performance for an extended period.

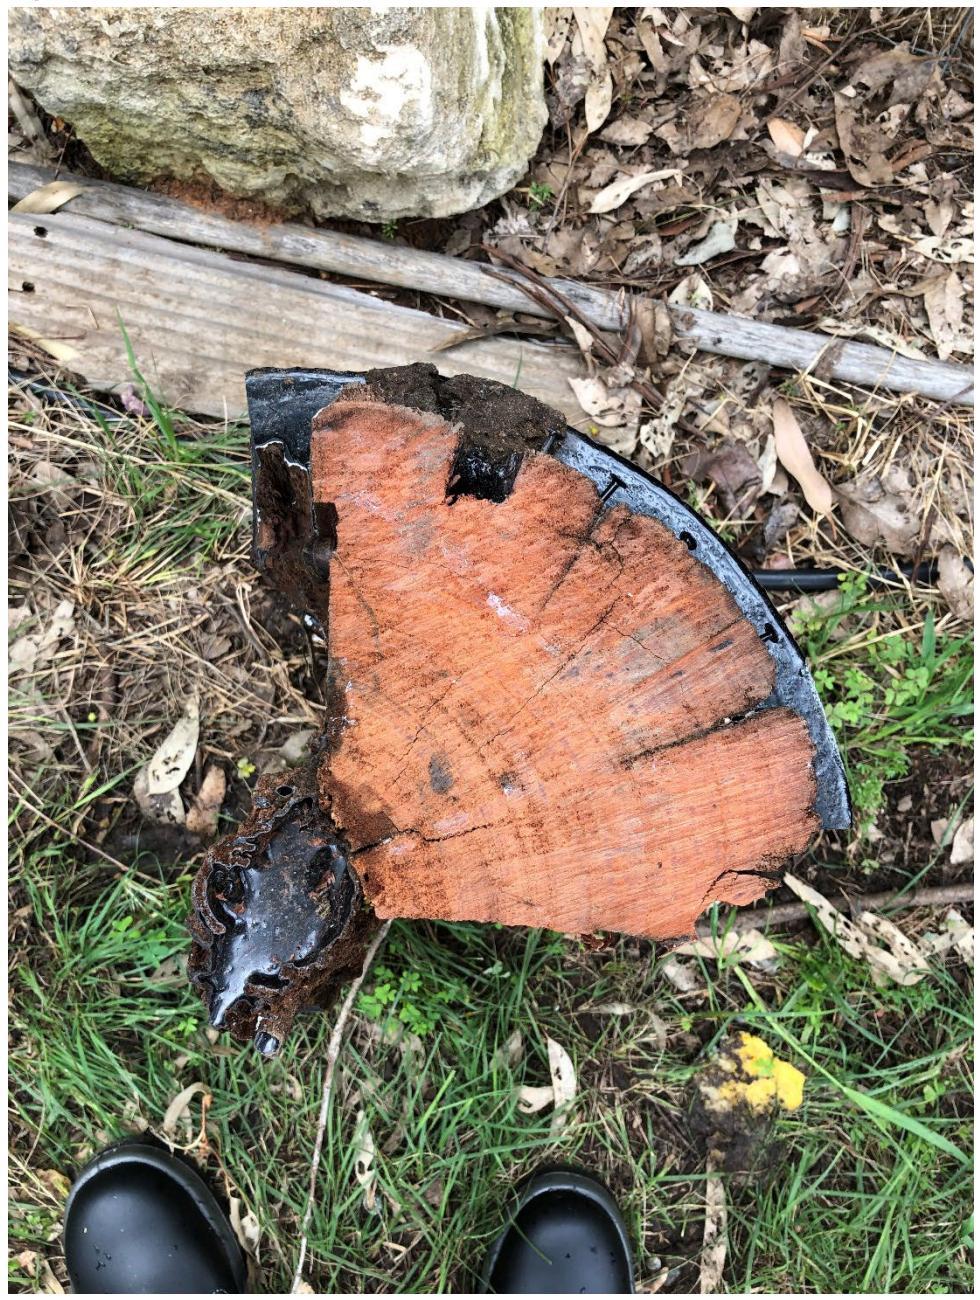
Figure 4.6: Section of pile treated with Technirez R1025

The Technirez section was observed to be so hard that it could not be cut with a chainsaw, damaging the blade when attempted. As a result, the pile was split into wedges (Figure 4.6), making it difficult to assess internal crack penetration. It was, however, observed from a cut at the top of the pile that the Technirez product within the internal pipe was level with the outer annulus, suggesting that internal flowability was achieved.

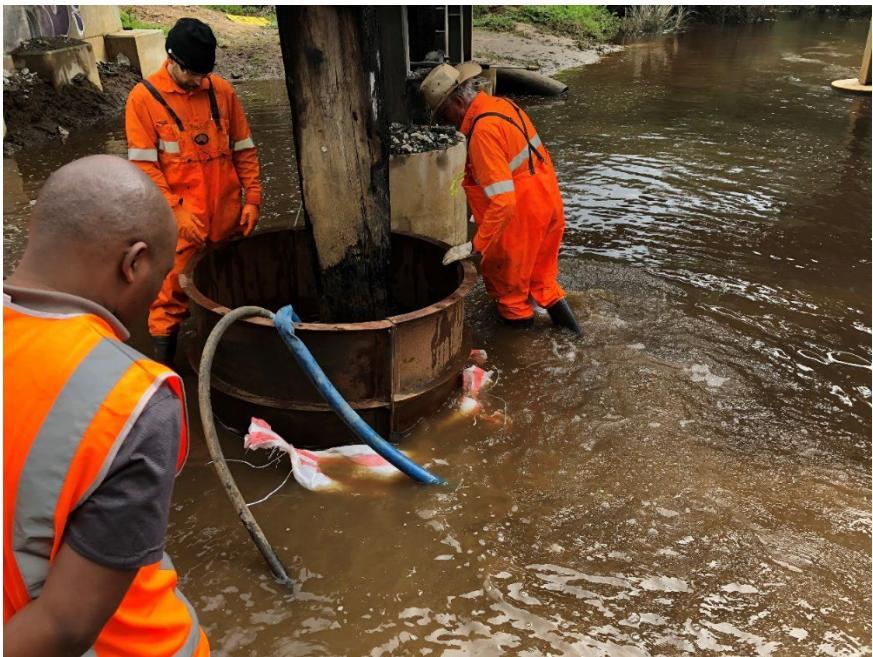
Figure 4.9: Pile isolation technique

Unfortunately, trial 3a was abandoned prior to epoxy being poured into the pile. While the works crew made every attempt on the day, substantial difficulties were created by the volume of water present. Despite the efforts in creating a works zone around the pile (Figure 4.9), the base of the repair zone remained submerged, creating visibility issues. Furthermore, the Ableflex could not be efficiently held in place nor adhesively attached to the pile.

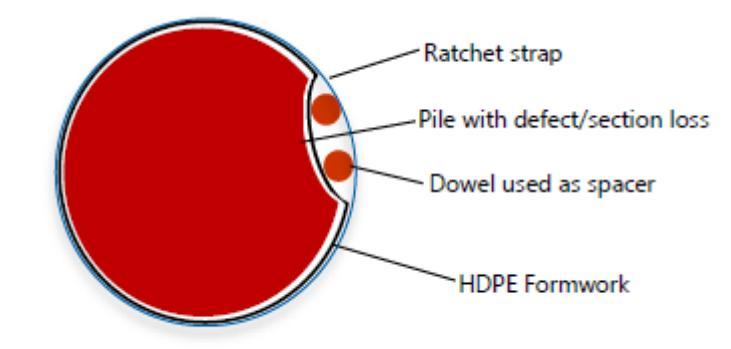
Figure 4.14: Sketch of pile featuring scallop defect

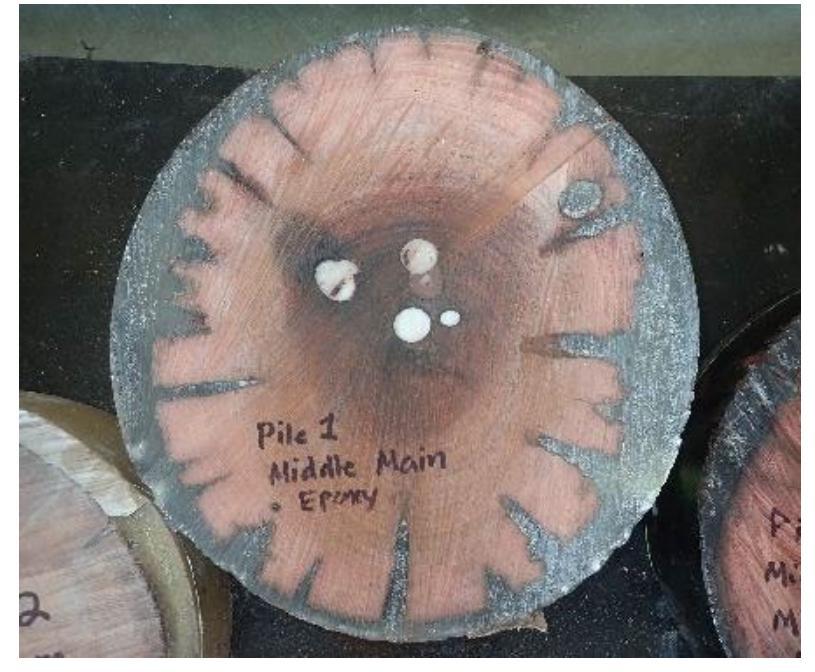
Figure 4.15: Main epoxy section Pier 3 Pile 1 showing soft white epoxy through the pipe

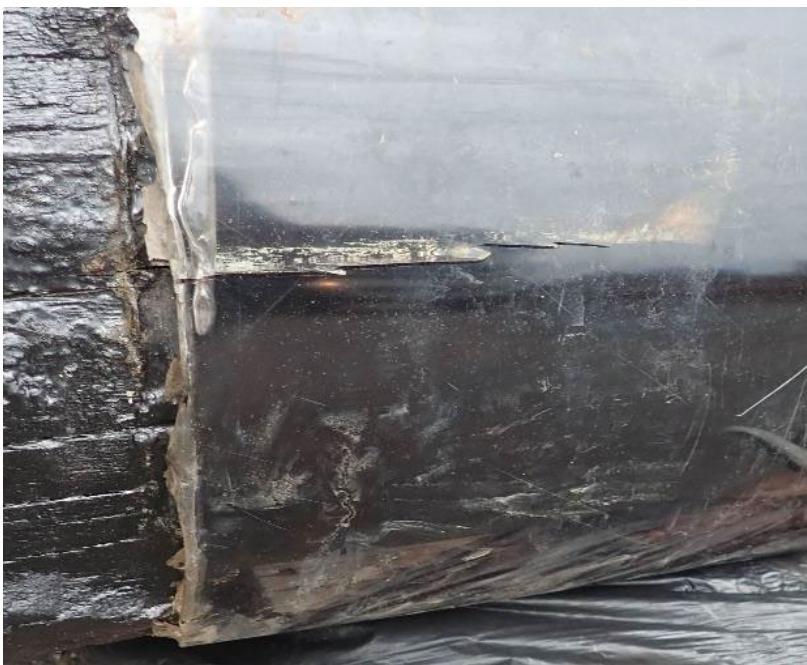
Thicker sections of the external annulus appeared to have cracking in areas corresponding to internal splitting. However, this cracking did not propagate into pile splits, consistent with historic results (see Figure 4.16).

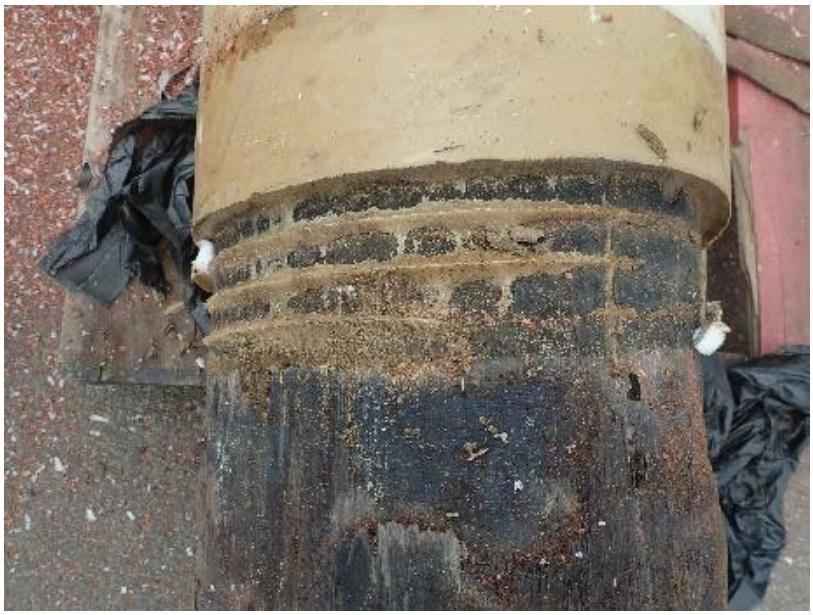
Figure 4.17: Ableflex interaction

The plug epoxy of both variants penetrated most splits effectively; however, it did not capture all of them. The bottom section of the repair (the plug mix) was also notably harder than the pure epoxy mixture in the upper section and was more difficult to cut through. The Ableflex seal and plug epoxy interaction of Pier 3 Pile 2 performed well and allowed for visualisation of the epoxy slowing as it cured travelling through the Ableflex loops (see Figure 4.17).
