Advanced Epoxy Timber Pile Repair – Stage 1 and Stage 2

Peter Dwyer, Eunice Chaw, Atteeq Ur-Rehman January 2024 Final Report

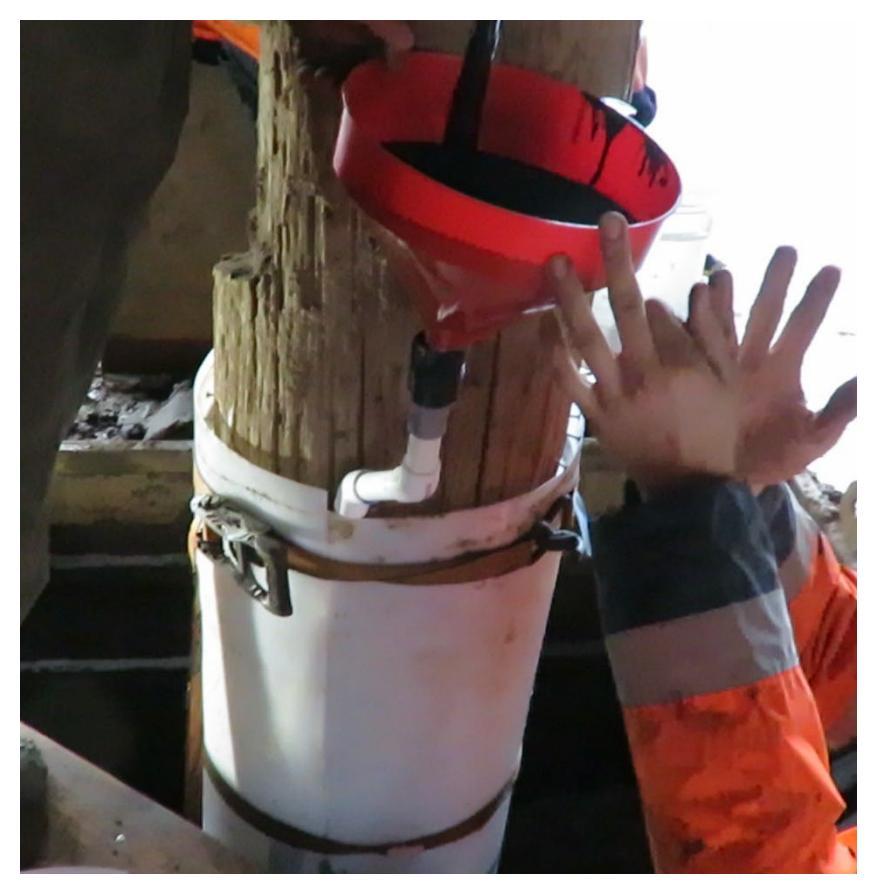
Throughout the installation process, it was observed that the higher viscosity of the Technirez created issues with the funnel and pipe arrangement that was being utilised for installation (Figure 4.3). To improve performance, the pipe section was later removed, and the epoxy resin was poured directly into the casting via a funnel.

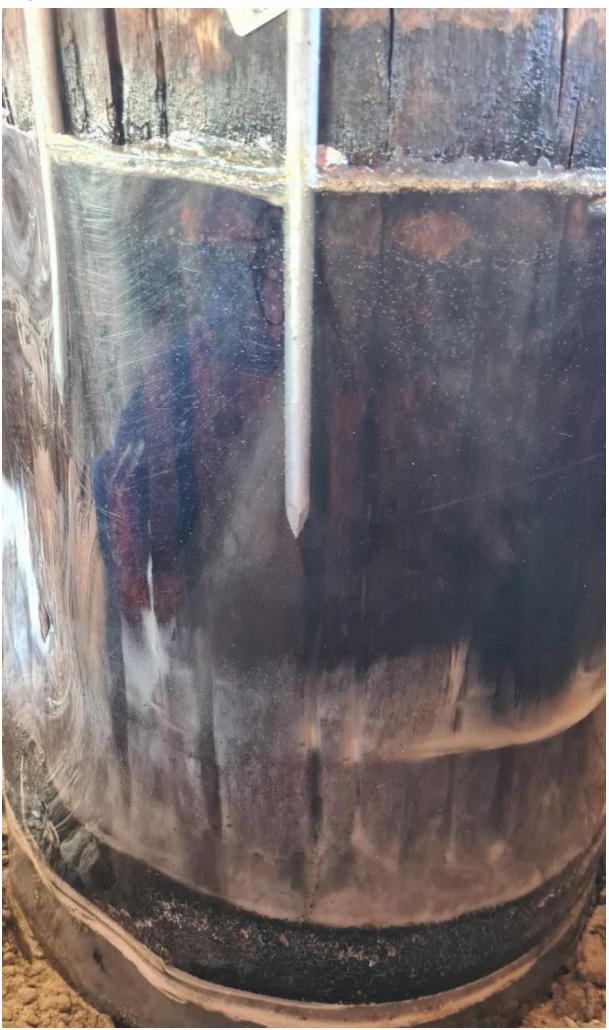
Figure 4.8: Section of pile treated with Technirez R1510

Figure 4.8 shows that the base of the epoxy appeared 'milkier' than the upper section. This phenomenon is the by-product of a hardener additive mixed in with the initial batches of epoxy to reduce the chance of leakage. A strip of Ableflex foam was placed as an initial stopper seal at the base. Ableflex was selected as it appears sufficiently flexible to absorb local variances in the section profile of the timber, while also providing enough of a seal to withstand the hydrostatic pressure of the epoxy pour.

Below the Ableflex, an air gap was left and a foam backing rod wrapped below to prevent the external cement mix from entering. The intent of this arrangement was to determine whether the Ableflex alone would be satisfactory in sealing the base of the formwork.

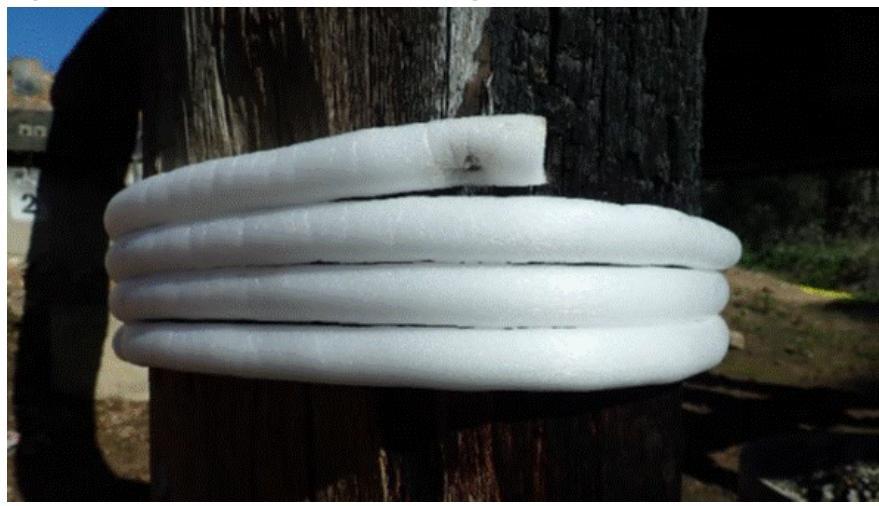
Figure 4.10: Closed cell Ableflex backing rod installation

A closed cell Ableflex backing rod (Figure 4.10) was found to be practical, with the above installation method achievable when utilising a 25 mm variant. Furthermore, the feedback on system constructability suggested this approach may be suitable for a submerged installation. Main Roads noted approximately 10 mm compression when the HDPE formwork was wrapped, resulting in an annulus of 15 mm. Seepage was observed between the layers of Ableflex, which was rectified through a caulked silicone at routine intervals around the installation. Overall, this approach proved the most cost effective of the materials trialled, with the Ableflex backing rod costing approximately \$1.00 per metre.

A closed cell Ableflex backing rod was concluded to be a suitable seal material when following the updated methodology and taking into consideration the comments outlined above.

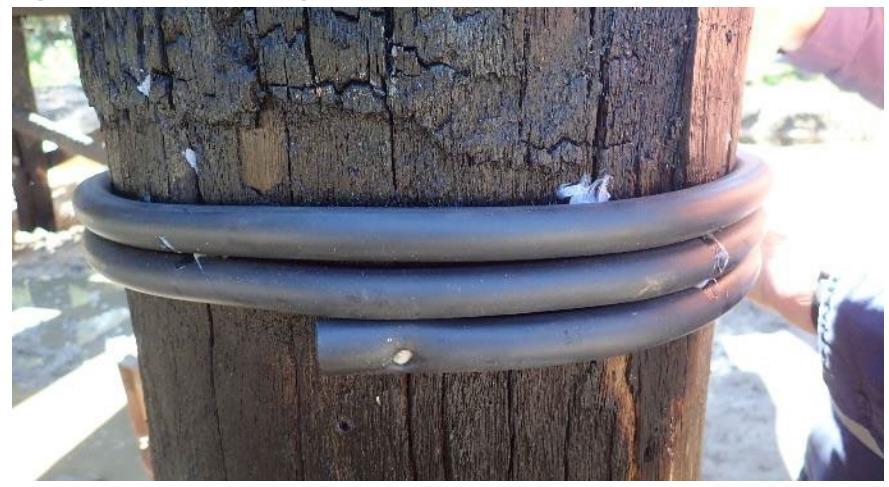
Figure 4.11: EPDM sponge rubber installation

Installation of the EPDM sponge rubber(Industrial Gaskets n.d.) was easy, which was attributed to the elasticity of the material, which could be tensioned when wrapped around the pile (Figure 4.11). However, unlike the Ableflex backing rod, the material appeared to lack compressibility, making it difficult to achieve a tight seal between the formwork wrapping and HDPE sheeting. This material was also not cost effective relative to other products trialled, costing approximately 10 times the price of the Ableflex rod.

The EPDM sponge rubber was concluded to be unfeasible due to its cost and lower relative compressibility relative to the other options trialled.

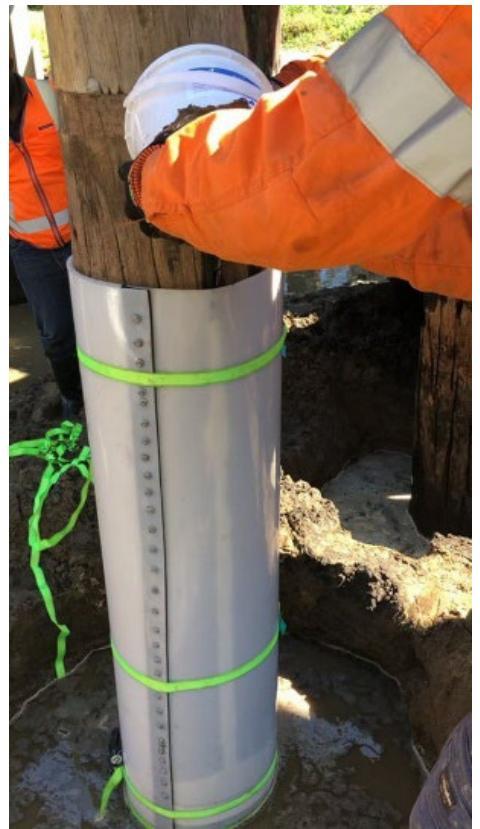
Figure 4.12: View of vertical seam

A vertical seam arrangement (Figure 4.12) was utilised in trial 3b. Insertion of a 12.7-mm thick strip of closed cell neoprene foam tape was used to seal the HDPE sheeting vertical joint. Compression was applied to the area through stainless steel tek screws at 50 mm centres.

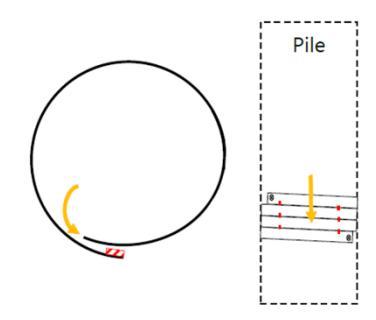
Figure 4.13: Sketch of vertical seal and base layer interaction

Slow epoxy leakage was observed around the 'loop channel' (area between Ableflex layers), which is believed to be a result of the interaction between the vertical seal and Ableflex base layer (refer to Figure 4.13). This observation should be addressed by future adjustment of the formwork overlap/seal detail.

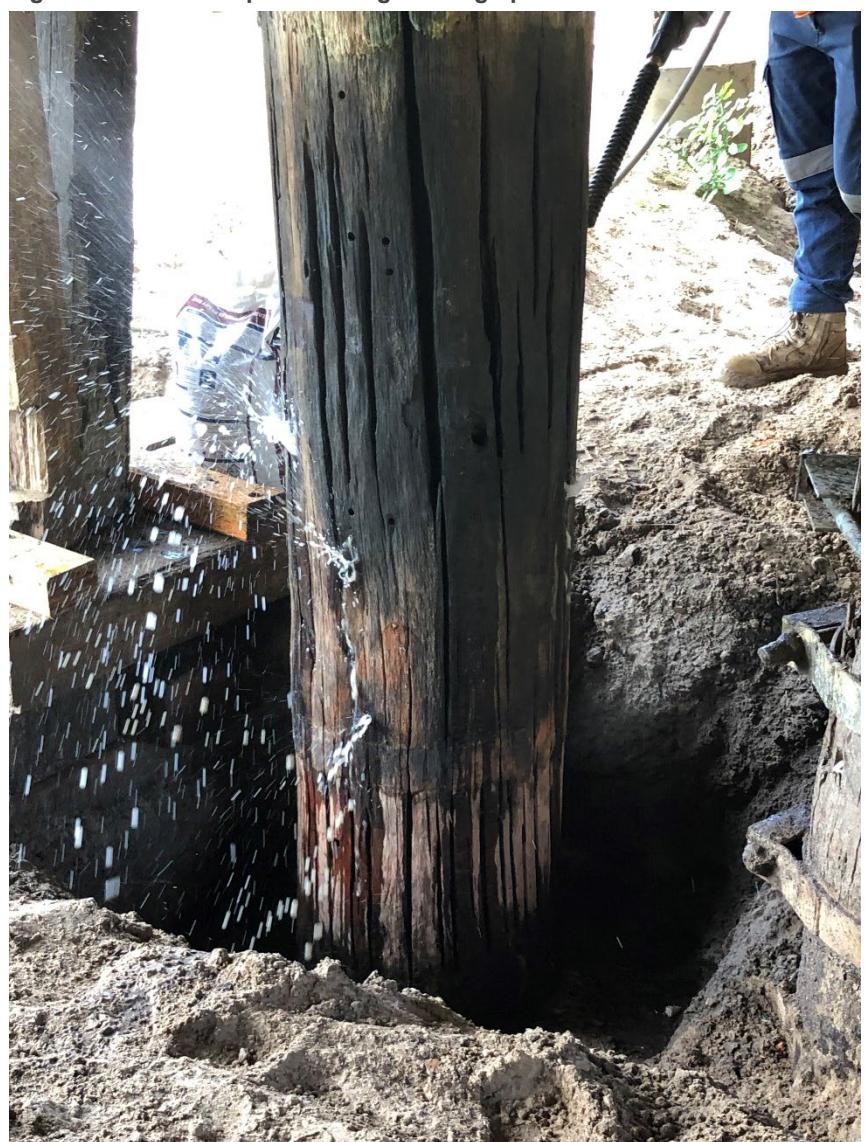
Figure 4.18: Timber pile cleaning with high pressure water

Pile sections cut as part of trials 1 and 2 showed that while the current cleaning process (Figure 4.18) is successful in removing the majority of trapped debris, it does not remove the complete quantity. Following the successful outcomes of trial 3, size and quantity of preparation holes are now stipulated as part of the pile preparation methodology.
