WARRIP

WESTERN AUSTRALIAN ROAD RESEARCH
AND INNOVATION PROGRAM

Management of Long-lever Cantilever Sign Structures

Hanson Ngo, Simon Orton,
and Mahes Rajakaruna

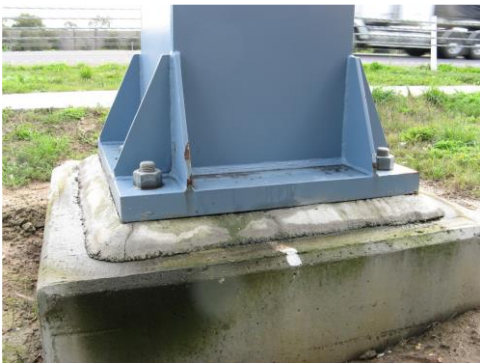
Figure 2.6: Base plate anchorage assembly

Morris and Thomas (2009) reported that an anchor rod within the base plate anchorage (Figure 2.6) for one gantry (carrying the Broderick Road sign), located near Geelong, Victoria, was completely fractured. The failure surface of the anchorage rod was found to have 'beach' marks which indicated that the mode of failure was fatigue. Outcomes from a monitoring program undertaken on this structure after being re-erected suggest that the failure was due to accumulation of fatigue damage as a result of significant vibration caused by wind-induced vortex shedding.

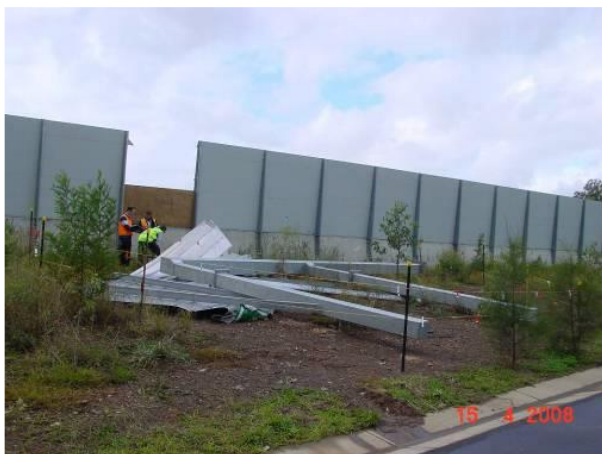
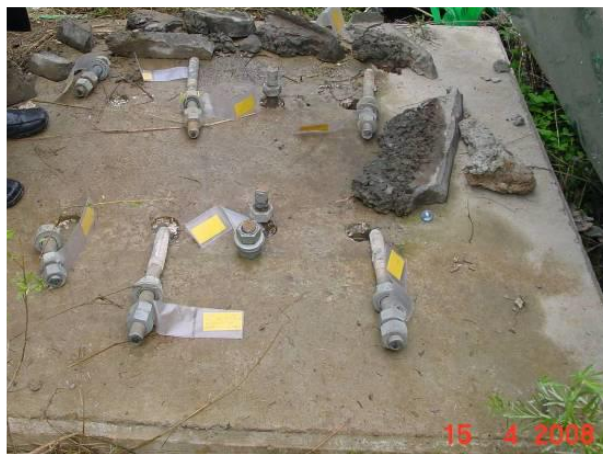
Figure 2.7: Failure of a cantilever sign structure in NSW, 2008

In NSW, a large cantilever sign structure collapsed onto the traffic carriageway near Blacktown in 2008 (Figure 2.7). An investigation was undertaken by the RTA (former TfNSW) into the failure consisting of ultrasonic testing and material tests of the failed anchor bolts. It was reported that the possible causes of failure included: (i) the lack of grout in recesses and under the base plate that resulted in a large unsupported length of the bolts, (ii) fatigue damage (indicated by ratchet marks and beach marks) in the bolts, and (iii) the as-installed bolts were significantly under strength, with nuts of a lower grade than as designed and the use of Grade 8.8 bolts which was not compliant (material test results indicated that the microstructure of the bolt was not compliant with AS 4291.1 for Grade 8.8 bolts which requires a quench and tempered (martensitic) microstructure).

a. Fallen sign structure

b. Failed anchors

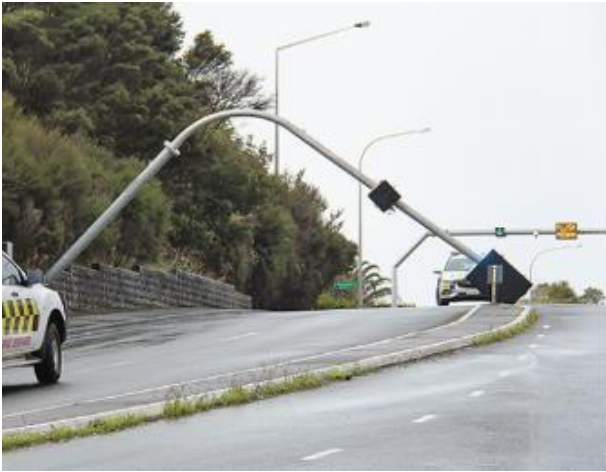
Figure 2.8: Failure of a cantilever sign structure in Auckland, NZ, 2019

Strong wind was believed to be the cause of a collapse of a cantilever sign structure in Whangaparaoa Road, Auckland in 2019 (Figure 2.8). The failure appeared to occur at the base of the pole; however, no further details were reported.

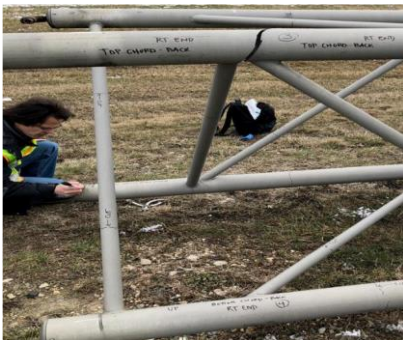
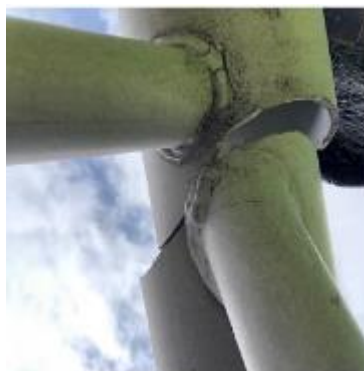
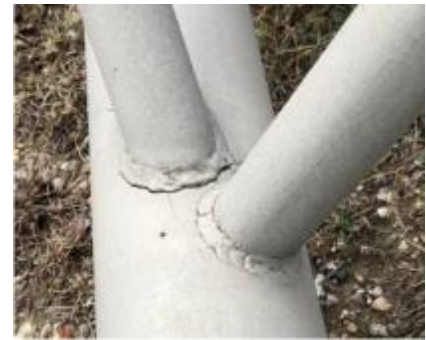
Figure 2.9: Failure of cantilever truss members

Nims et al. (2019) investigated a 4-chord truss CSS structure, located on Alum Creek Drive at the I-270 interchange near Obetz, Ohio, after the structure failed and was removed from service, to determine the causes of failure. On this structure, typical fillet welds were used for the connections between the chords and the diagonals. Figure 2.9 shows that the failure occurred at 2 different locations including the top chord and the weld between the chord and the diagonals. The top chord was completely severed, while the welds had cracked up, but the crack had not yet advanced through the chord. Both locations were near weld junctions of the diagonals and chord.

The paper reported that there was an interaction between an instantaneous material failure due to overloading and a slower material failure due to fatigue. The former occurred on a small smooth surface area and resulted in the initiation of cracks, while the latter occurred on a much larger uneven and irregular surface. The most severe fractures were located along or adjacent to the welds connecting the cross members to the chords.

a. Fracture of top chord

b. Close-up of fracture of chord

c. Weld cracking

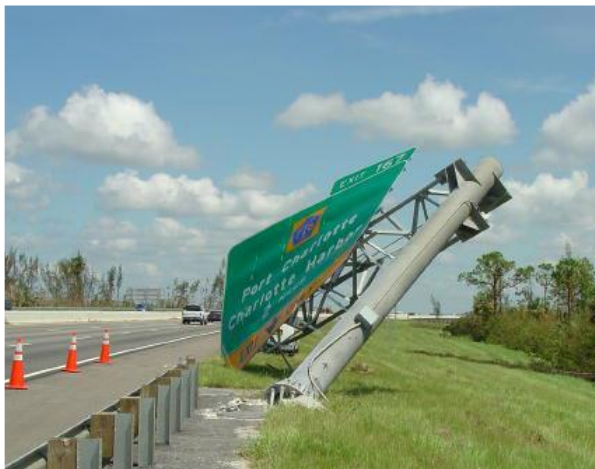
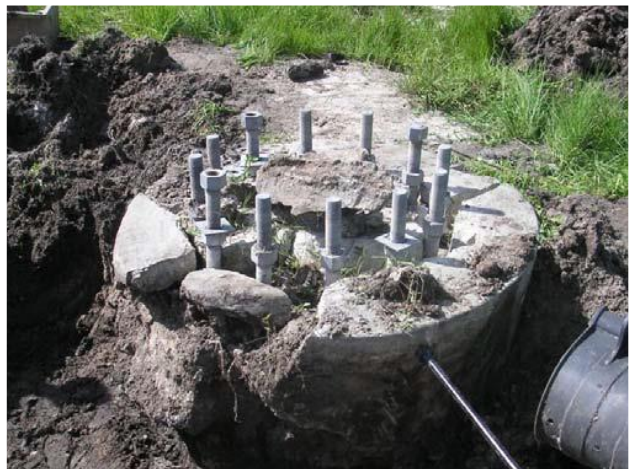
Figure 2.10: Failure of a cantilever sign structure in Florida due to hurricane

Furthermore, Figure 2.10 shows the failure of a cantilever structure in Florida after a hurricane (Cook & Halcovage 2007). The circular concrete foundation failed as a result of an applied torsion which caused a concrete breakout failure due to shear within a plane parallel to the edge of the anchors. It was obvious that this failure was due to overloading.

a. Fallen post

b. Close-up of foundation concrete breakout

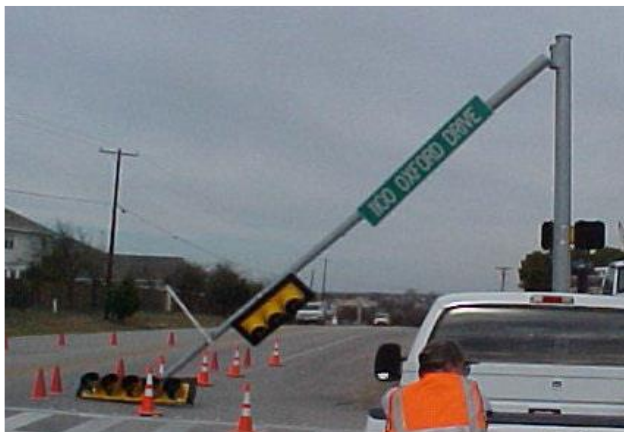
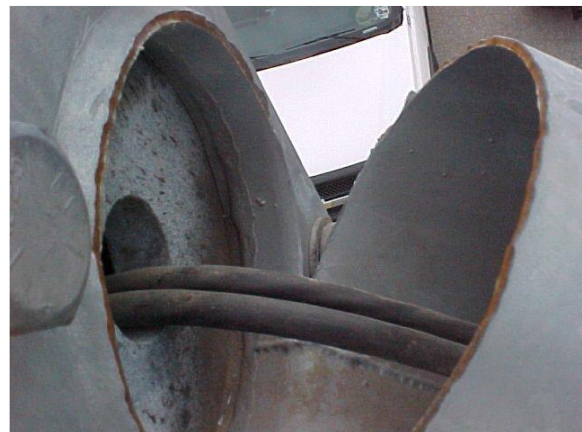
Figure 2.11: Failure of a cantilever sign structure in Pflugerville, Texas

Florea et al. (2007) reported a falling cantilever highway sign structure in Pflugerville, Texas due to fatigue failure resulting from overstressing, poor welding quality, and low fatigue strength (Figure 2.11).

a. Fallen cantilevered arm

b. Fatigue failure at mast-arm connection
